# Insight

Nemaha Natural Resources District

## Modern Solutions for Aging Watershed Infrastructure

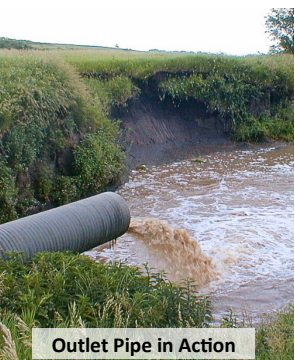
Outlet Pipe in Action

The Nemaha NRD is home to more than 400 dams, many of which are now over 60 years old. As these structures age, the wear of time is becoming increasingly visible—especially in the outlet pipes. Corrosion is most common in the upper portions of the corrugated metal pipes, where the combination of moisture, air, and soil creates ideal conditions for rust to form and gradually weaken the metal. Over time, rust perforates the riser, holes develop in the outlet, and welds begin to fail. Eventually, the structural integrity of the entire system is at risk.

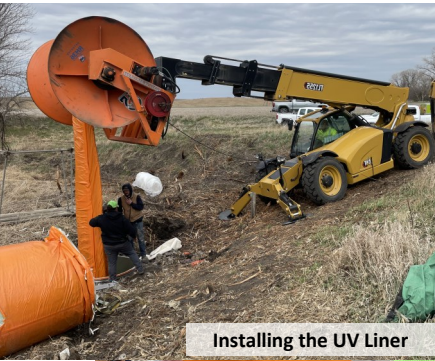
Installing the UV Liner

- **UV-CIPP:** A modern and highly effective solution now being used is Ultraviolet Cured-In-Place Pipe (UV-CIPP). This trenchless technology eliminates the need for digging by restoring the pipe from the inside. A resin-saturated liner is inserted into the existing pipe and cured using ultraviolet light, forming a strong, jointless, corrosion-resistant pipe within the old structure.

Unlike surface coatings, UV-CIPP provides full structural renewal. It adds strength, improves hydraulic performance, and extends the structure's life by an estimated 75+ years—longer than the original design.

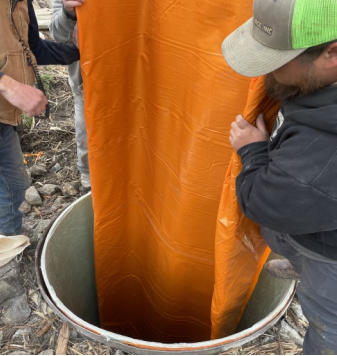
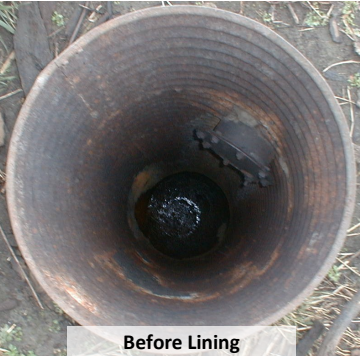
Before Lining

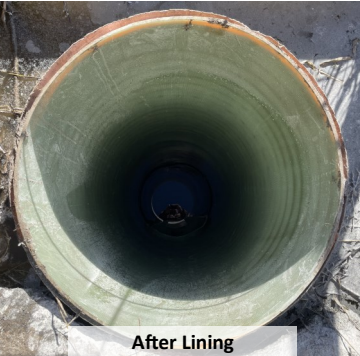
After Lining
